Lighthouse Making History at Cape Elizabeth Lighthouse

The elegant 67-foot east tower at Cape Elizabeth is currently undergoing an historic rehabilitation to its concrete base, and in the process, the 'makeover' is making its own new history.

The repair work to the light's concrete base, which is being managed by the nonprofit American Lighthouse Foundation and facilitated by J.B. Leslie Masonry Company from South Berwick, Maine, is addressing years of surface spalling to the structure caused by age and the elements.

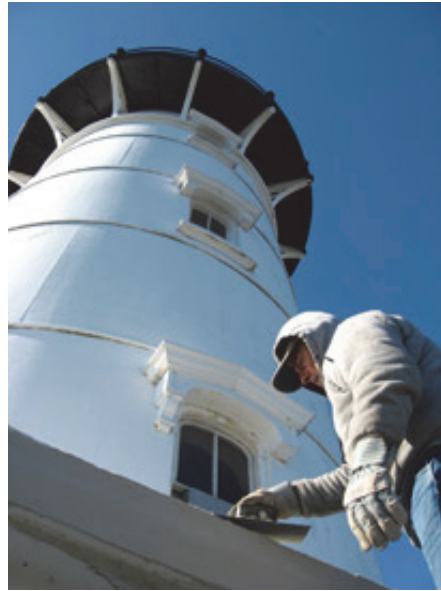
Ken Morse repairs a top section of the concrete base at Cape Elizabeth Lighthouse

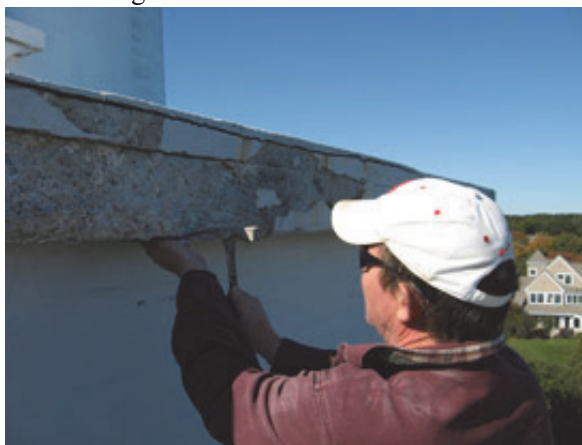
Jim Leslie uses hand tools to carefully remove failed cement down to hard substrate on a concrete overhang

Leslie goes on to say, "The important part of a project like this one is the careful prep work to remove the sections of failing

cement. We removed the failing cement down to the existing hard substrate and are using the closest match that could possibly be duplicated mixture-wise to the original grappier cement."

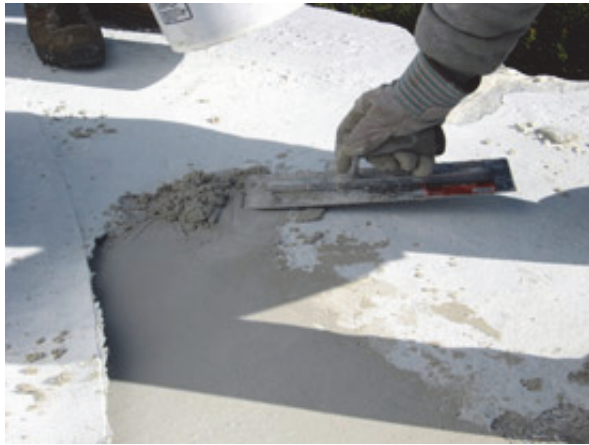
A close-up view of repairs to a spalling area on the top section where the tower's flashing is attached to the concrete base

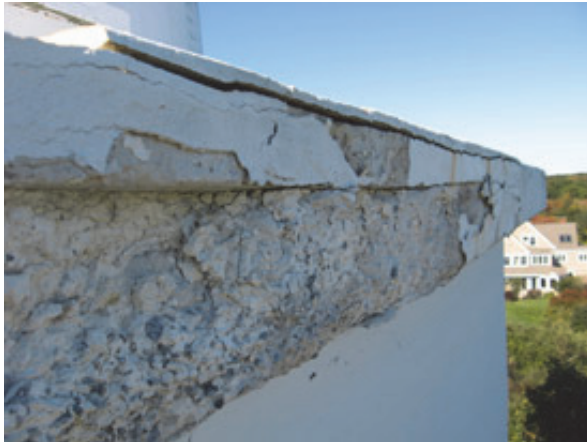
A close-up view of the deterioration that occurred to the light's concrete base on the east side

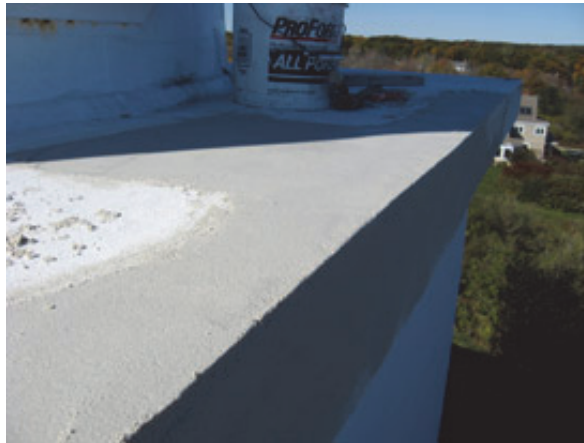
A close-up view of the repair work by J.B. Leslie Masonry on the east side of the concrete overhang

Jim Leslie, president of J.B. Leslie Masonry Company notes, "This project has presented a few challenges - one being the concrete overhangs. In repairing the spalling edges, you cannot just simply pour new cement or apply a skim coat patch. We built wood forms to match both the original board lines and concrete form marks on the cement base in order to replicate the historic appearance of the structure, as well as to ensure the durability of the repair work."

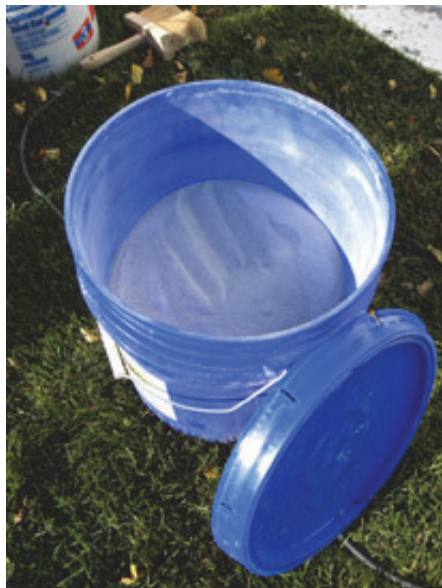
(Photo by Bob Trapani, Jr.)
A view of the special cement mixture from Edison Coatings

Testwell, Inc. of Ossining, NY. This analysis report determined what type of cement we were dealing with – in this case grappier cement that is no longer manufactured. The data was then reviewed by the Commission and later enabled Edison Coatings of Plainville, CT to closely duplicate a cement mixture consistent with grappier cement."

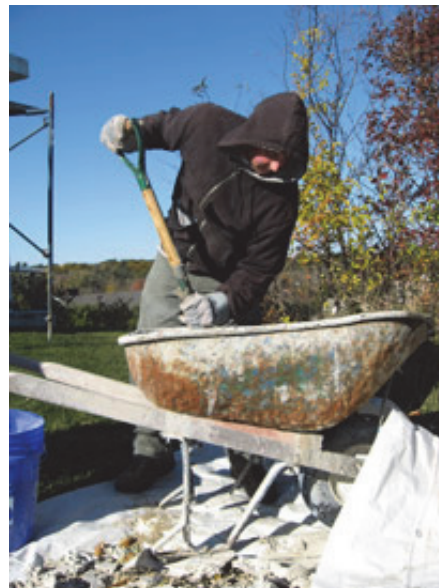
(Photo by Bob Trapani, Jr.)
Jake Johnson works to mix a round of cement

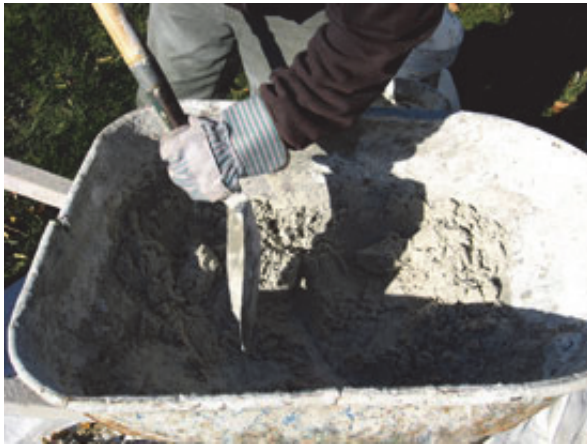
A close-up view of the cement mixture being prepared for application

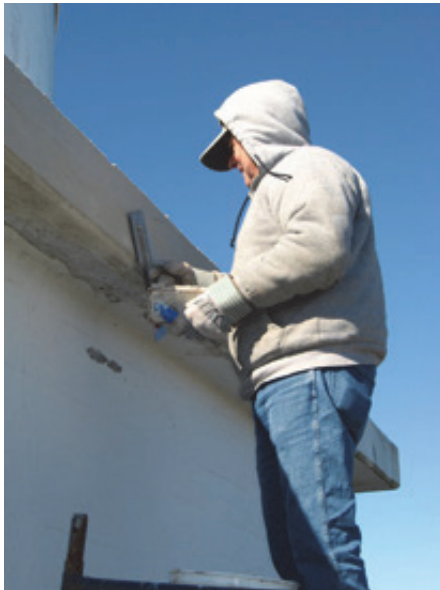
(Photo by Bob Trapani, Jr.)
Ken Morse applies new cement to repair spalling damage

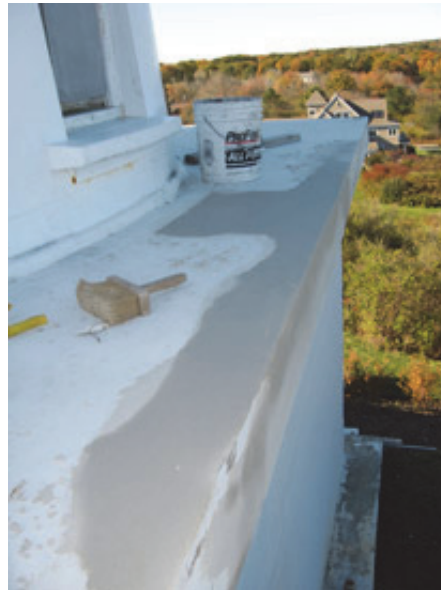
(Photo by Bob Trapani, Jr.)
Ken Morse applies new cement to repair spalling damage

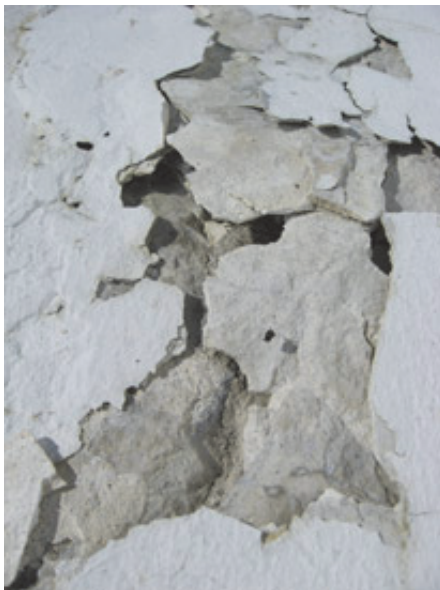
(Photo by Bob Trapani, Jr.)
A close-up view of failing cement on the top of the base

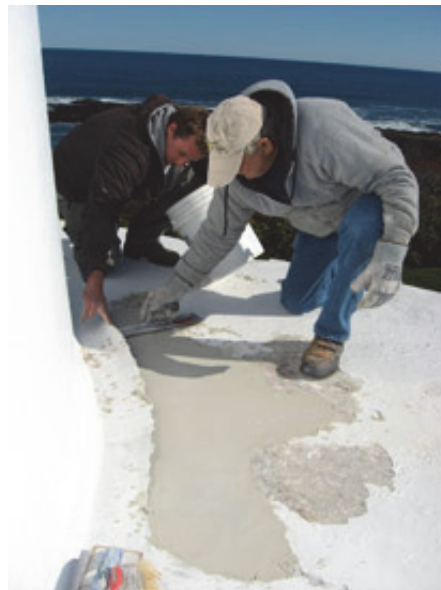
(Photo by Bob Trapani, Jr.)
Jake Johnson and Ken Morse repair a top section

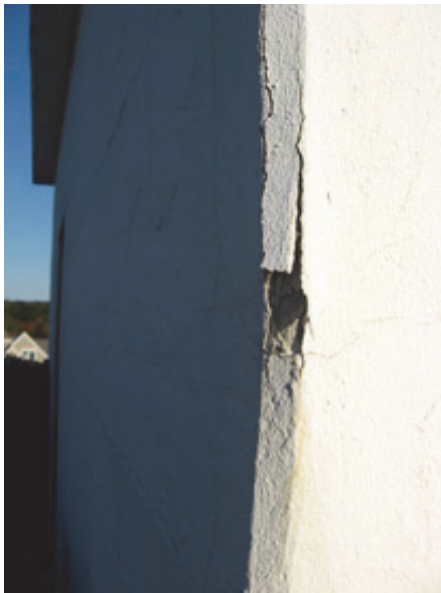
A close-up view of spalling
occurring on an corner edge
of the light's base

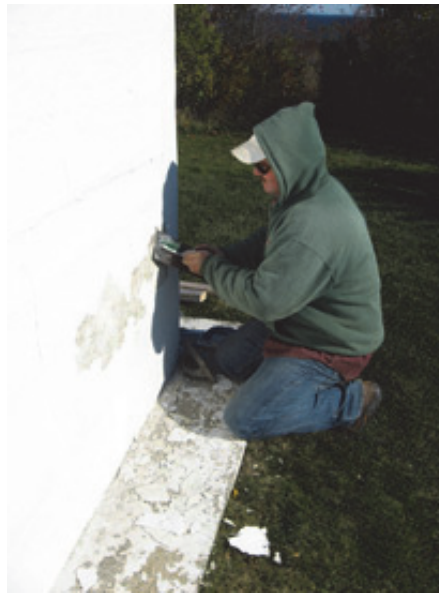
Jim Leslie works on prepping
a side section on the south
side of the base
